Traverse City Home Inspections, LLC

Your Property Inspection Report

Date of Inspection: 7/16/2019 Time: 5:00 pm
Order ID: 3896

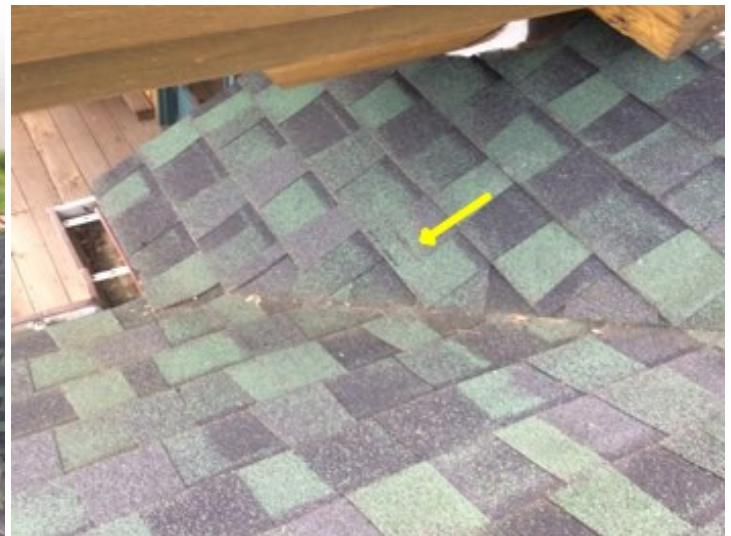
Ripped shingle at the bottom of the E valley of the upper N side should be replaced

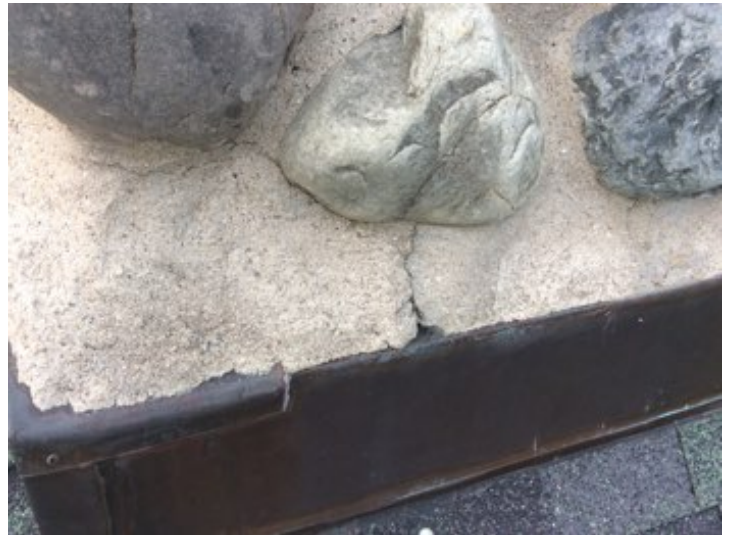
Cracks observed in mortar of chimney. We recommend sealing these areas to prevent water intrusion.

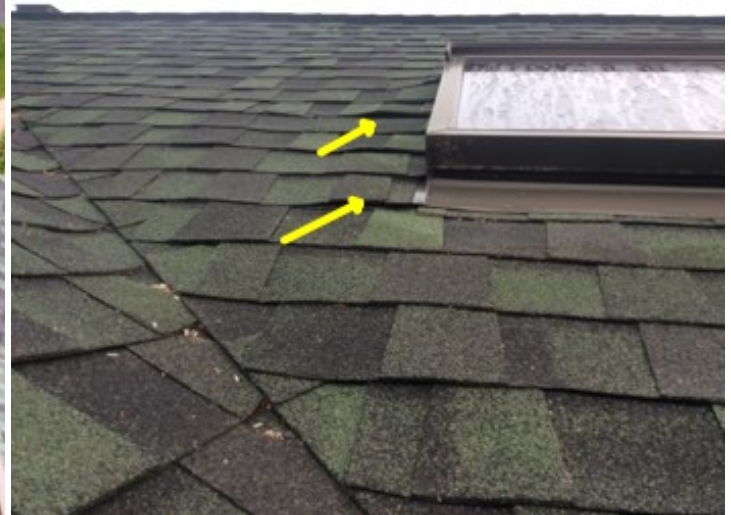
Lifted shingles/flashing near the E skylight on the Upper S side should be secured to prevent water intrusion and wind damage

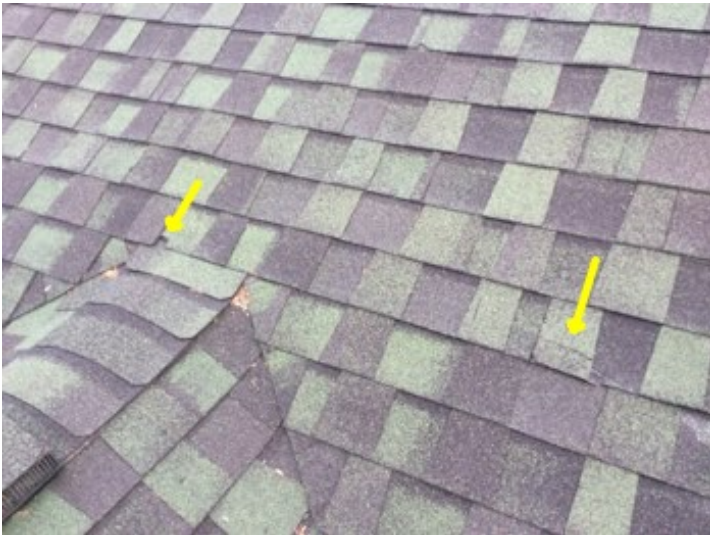
Ripped shingles near the upper S side ridge should be replaced to prevent water intrusion

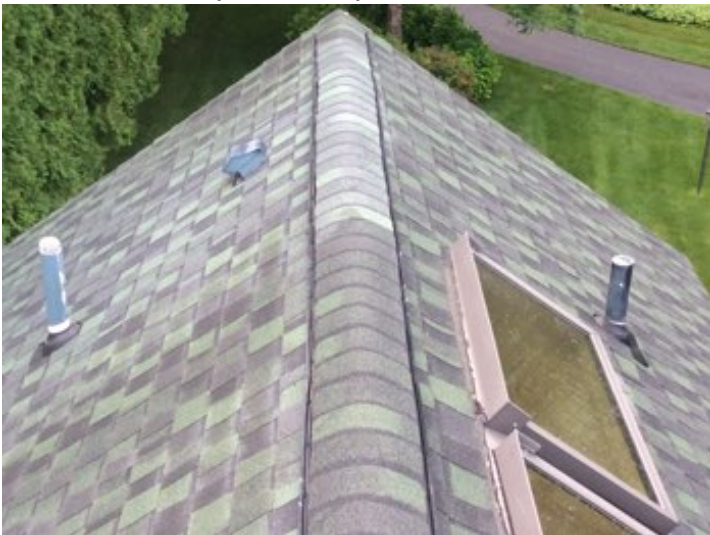
Upper SE waste vents appear secure. We recommend resealing face nails in flashing to prevent water intrusion.

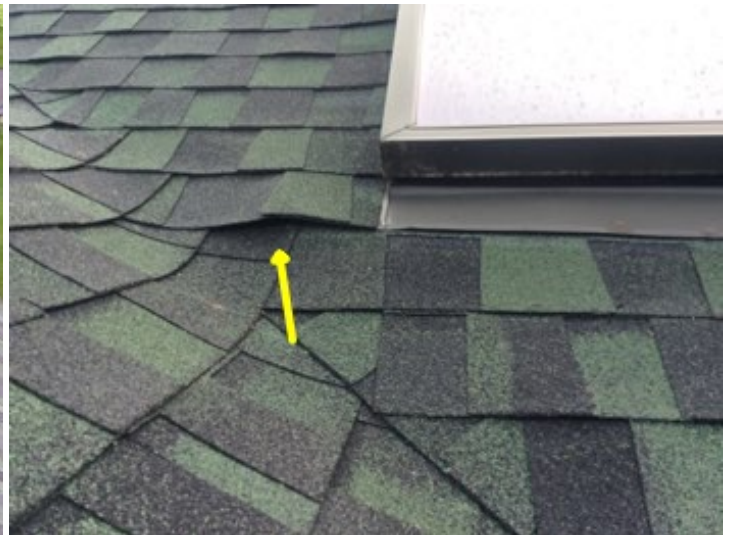
Lifted shingle/flashing at the upper SE skylight should be secured to prevent water intrusion and wind damage

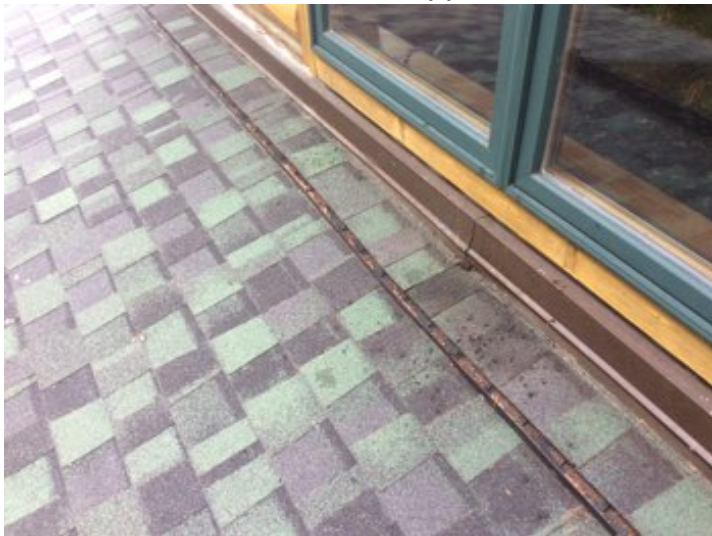
Possible bat droppings observed on the lower W side of roof. We recommend a qualified pest technician evaluate and treat as needed to ensure pest are not entering home.

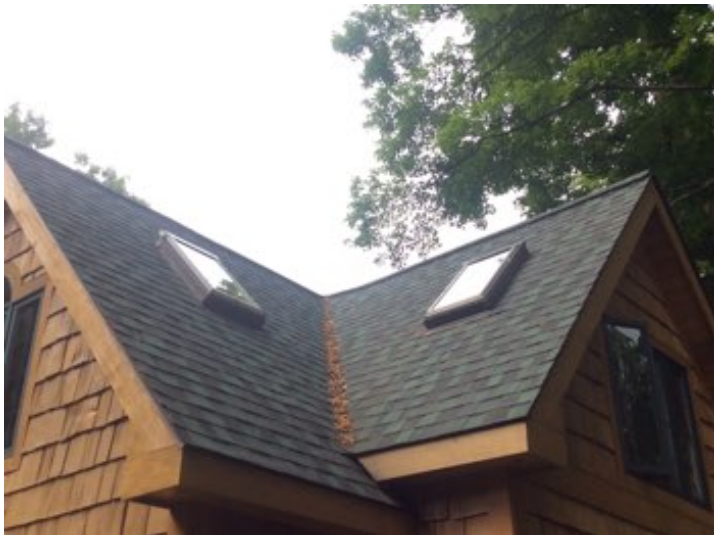
NE side of the outbuilding. We recommend cleaning off tree debris as it can hold moisture to shingles causing premature decay and a shortened shingle service life.

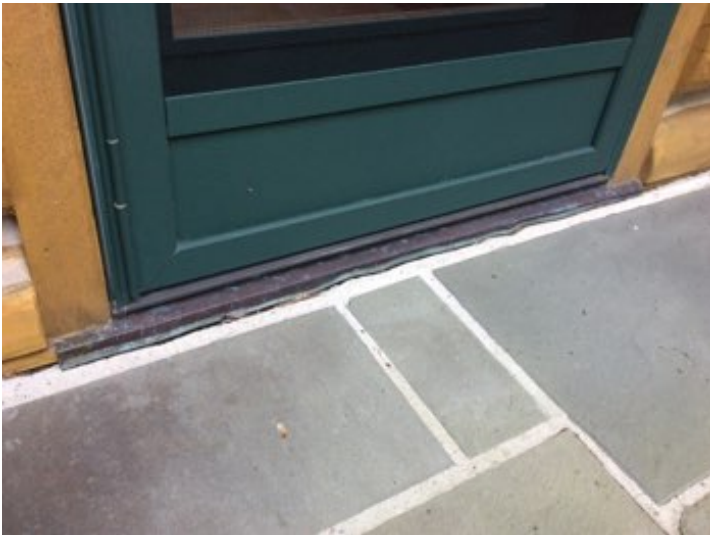
We recommend sealing the crack at the base of S side entry door to prevent water intrusion.

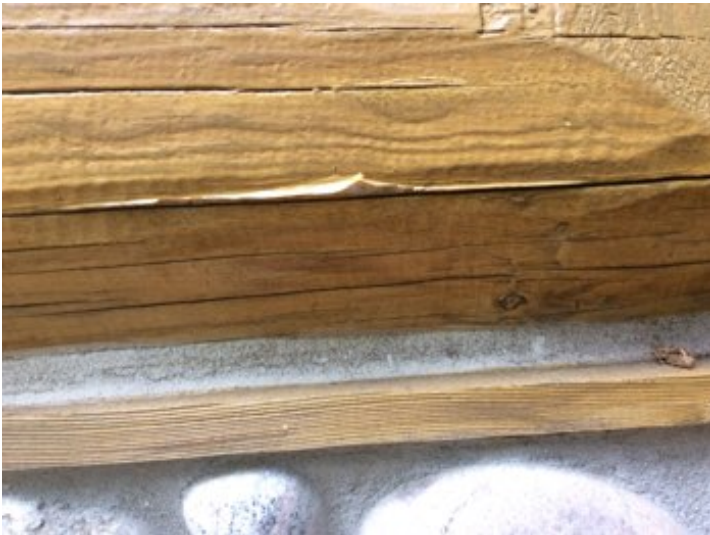
Chipping sealant observed at lower SE corner.
We recommend scraping and resealing these areas to prevent water damage.

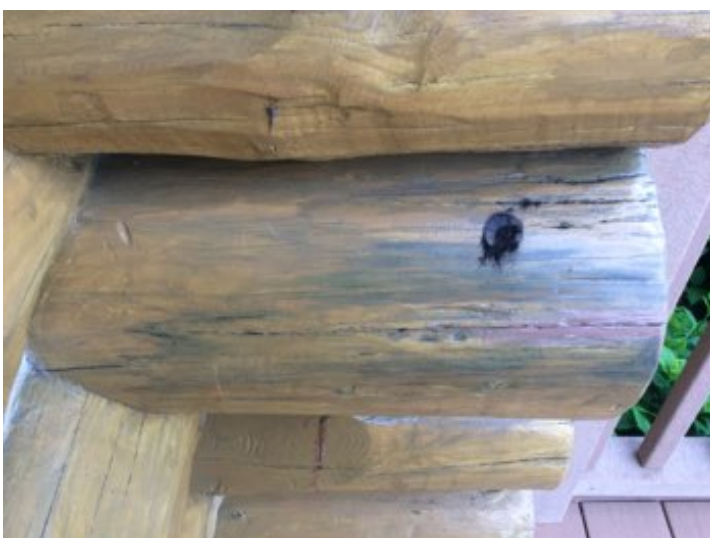
Slight decay observed at SW corner of NE deck.

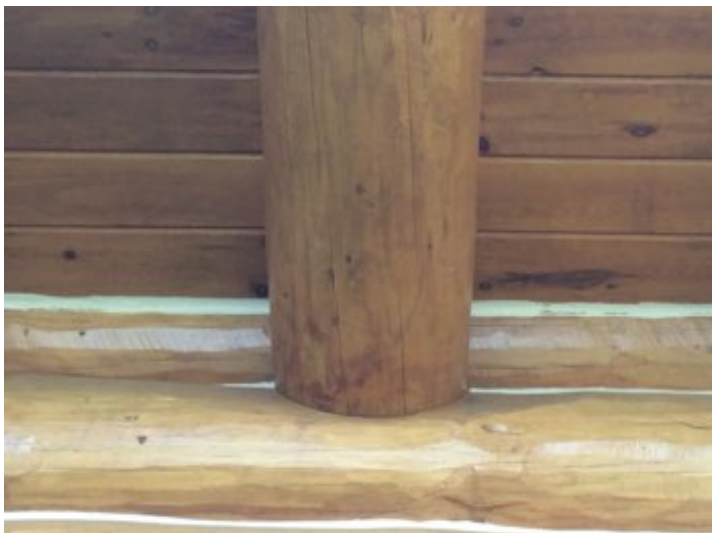
Cracked chinking observed above NW living room windows should be resealed to prevent water intrusion.

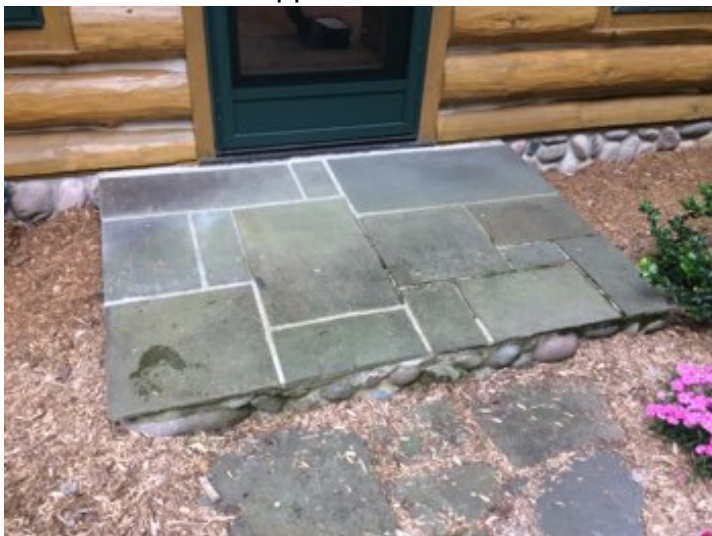
S side entry door step-S corner paver brick loose and should be secure, we recommend cleaning moss growth of as it can hold moisture close to the surface shortening its useful service life.

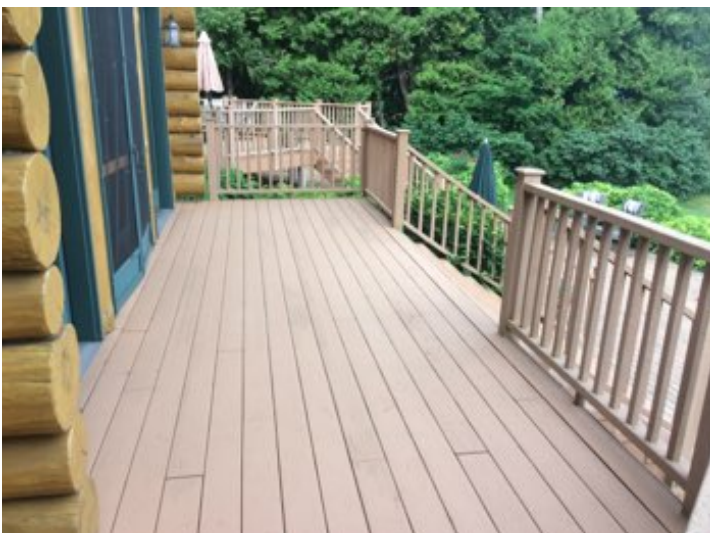
NE deck-W railing slightly loose and should be secured for improved safety.

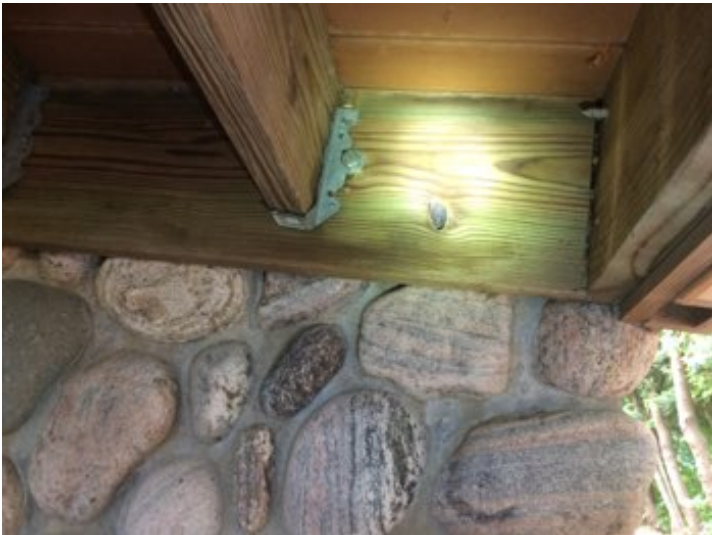
NW Deck 2x8 construction on 16" centers with 6x6 supports. Ledger board is bolted and not flashed. We recommend properly flashing the ledger board for improved deck safety.

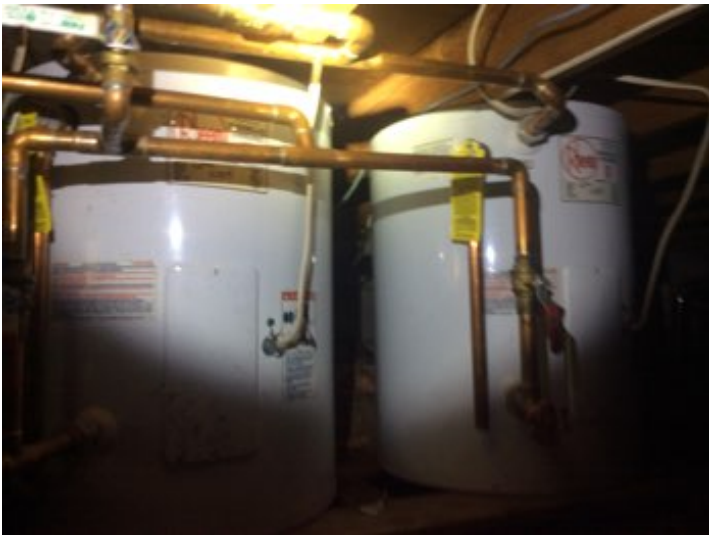
2-Rheem 19.9 gallon electric water heaters. Units responded to hot water testing. Average service life of a hot water heater is 5-15 years.

Manufacture dating is 1997. Units are past the end of its expected service life. Expect to repair or replace units at any time.

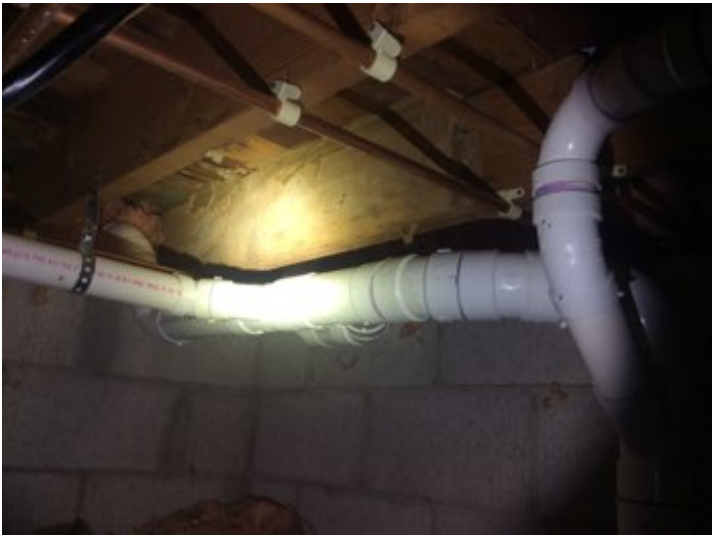
Repair observed under the bathroom appeared dry and secure at the time of inspection

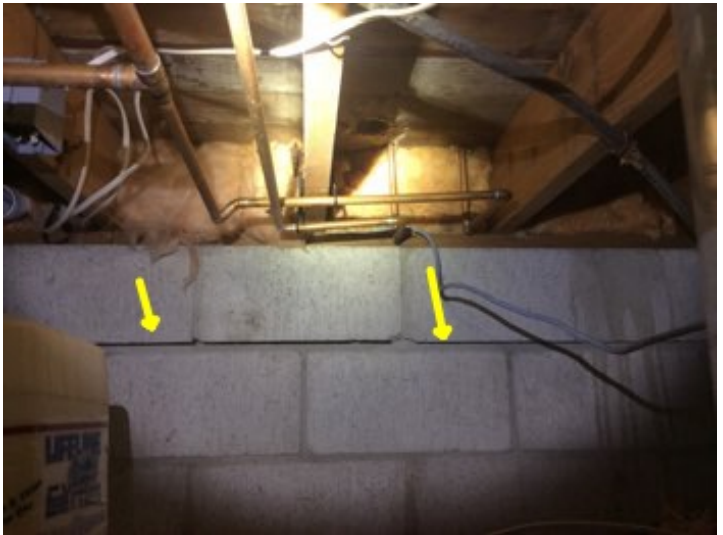
Cracking and slight gap in tuck pointing at the NE corner of the crawlspace. We recommend a qualified contractor evaluate and seal gap for further monitoring.

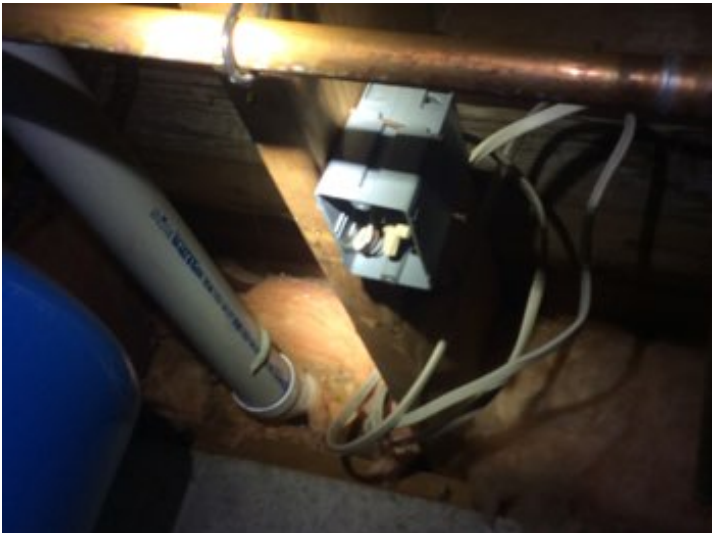
Missing electrical junction box cover should be installed

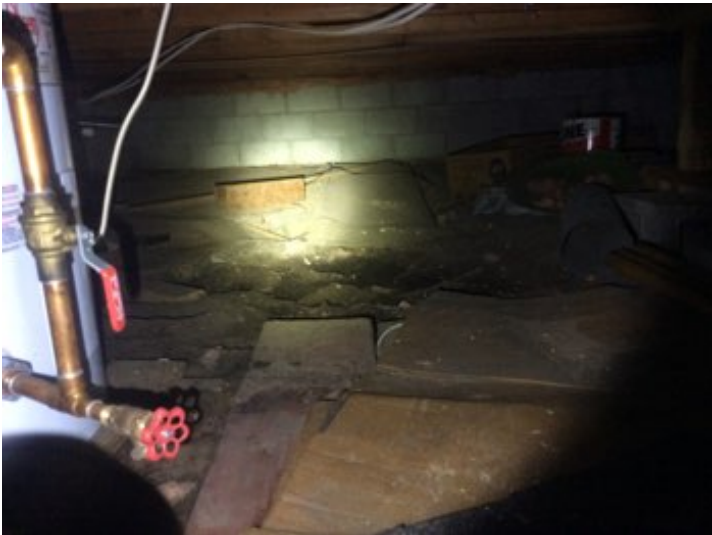
No vapor barrier in place. Signs of water observed. We recommend the installation of a vapor barrier to prevent organic growth from high humidity.

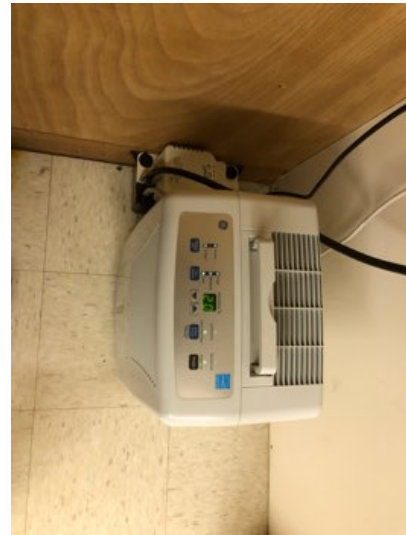
Portable dehumidifier located next to pressure tank does not function

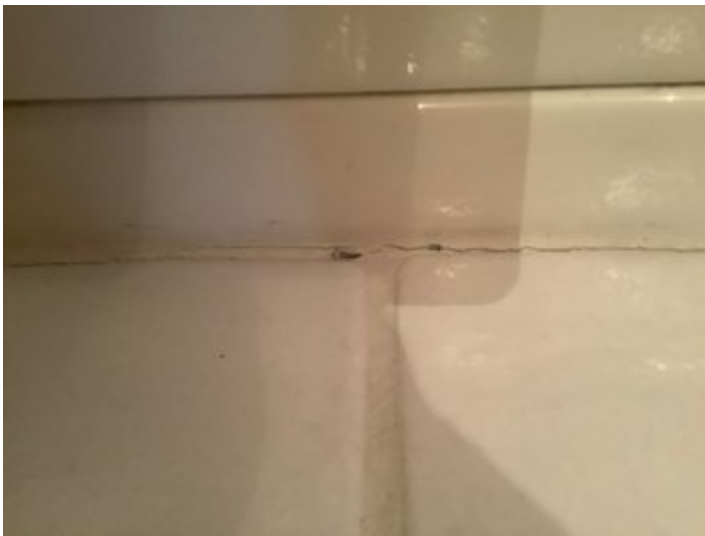
Leak observed below faucet, we recommend sealing.

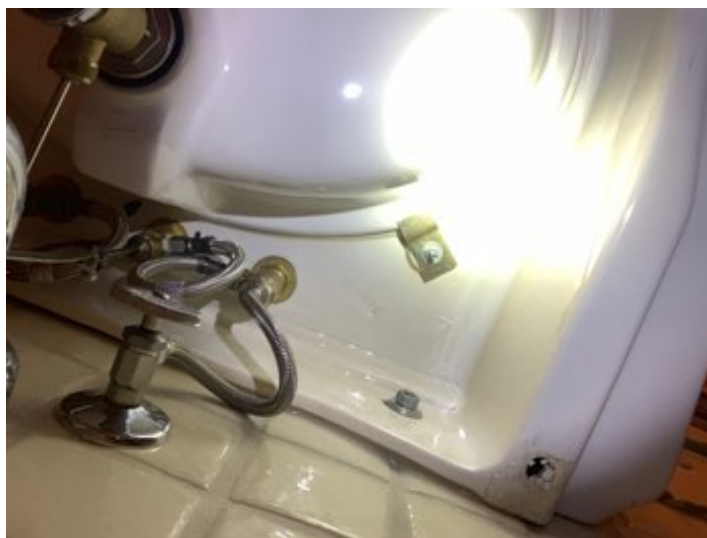
Leak observed under faucet, we recommend sealing.

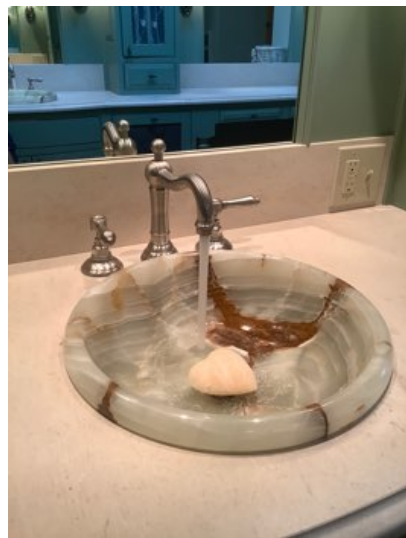
W sink drain stop not functioning properly

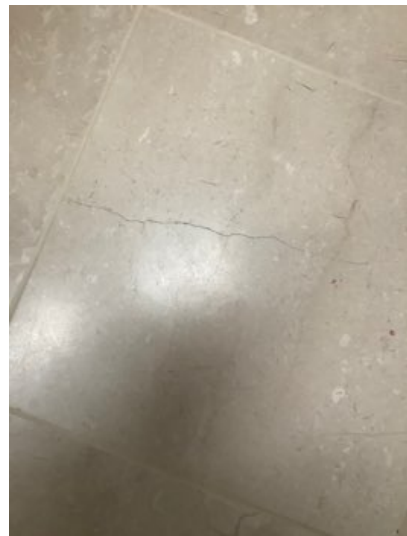
Crack observed in tile

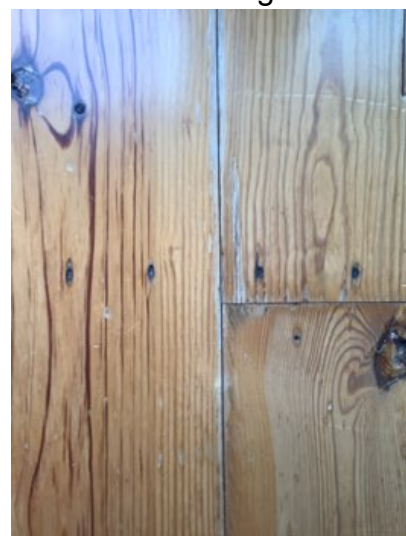
Water staining observed in front of N living room entry doors, area tested dry at time of inspection.
