Traverse City Home Inspections, LLC

Your Property Inspection Report

Date of Inspection: 7/16/2019 Time: 5:00 pm
Order ID: 3896

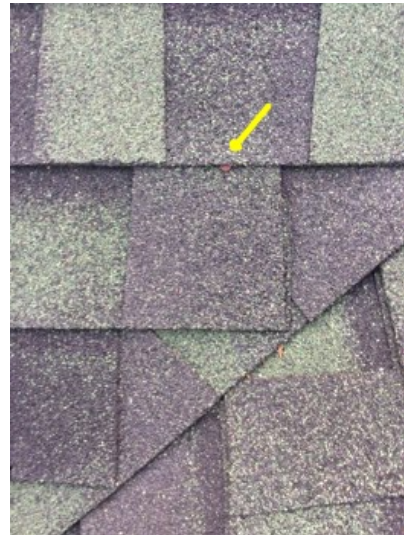
Exposed nail in the W valley of the upper NE dormer should be sealed to prevent water intrusion

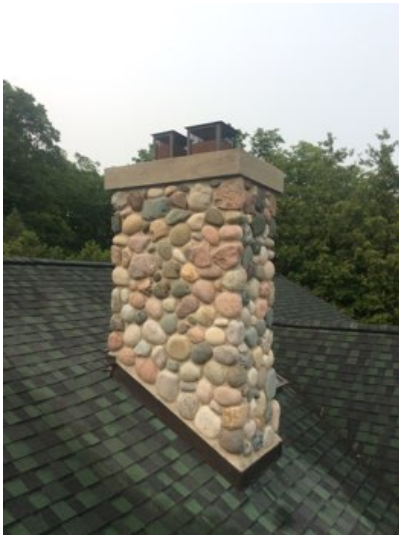
Chimney

Cracks observed in mortar of chimney. We recommend sealing these areas to prevent water intrusion.

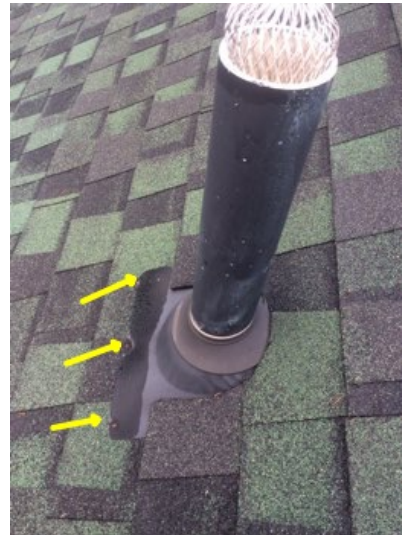
We recommend resealing the face nails of the upper SW waste vent flashing to prevent water intrusion.

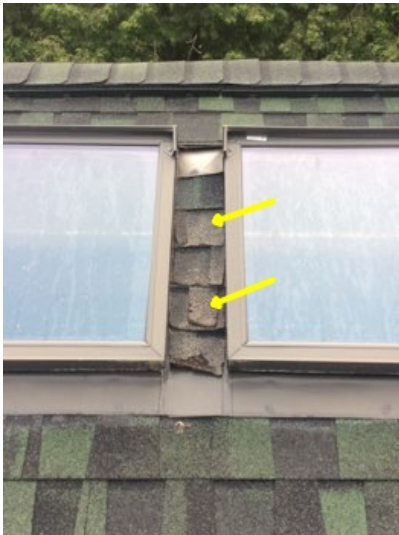
Decayed shingles between the upper SE skylights should be replaced

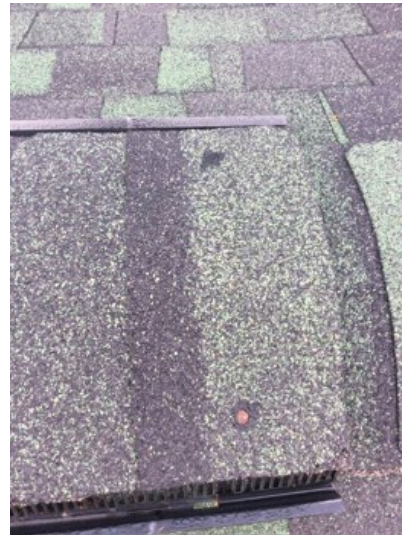
We recommend resealing face nailing at the end of ridge run shingles to prevent water intrusion.

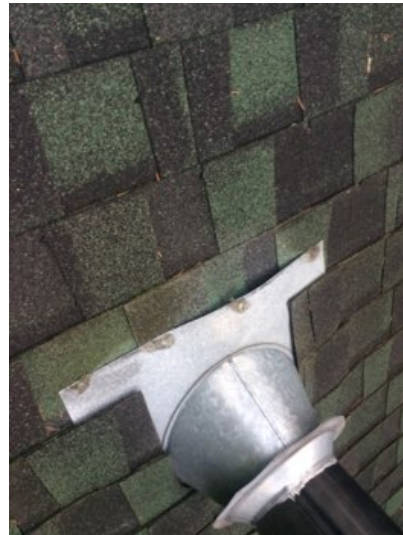
Lifted flashing of the lower NE vent stack should be secured to prevent water intrusion

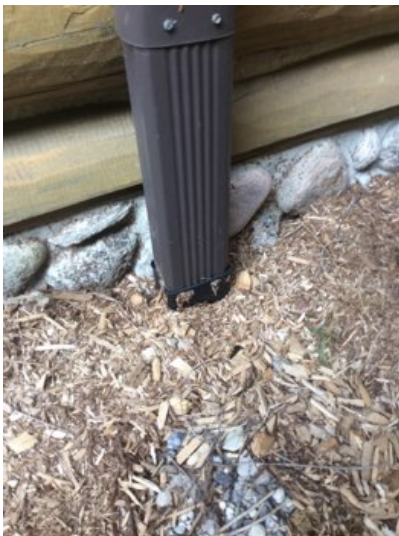
We recommend consulting with the seller to verify where underground gutter drainage system terminates to.

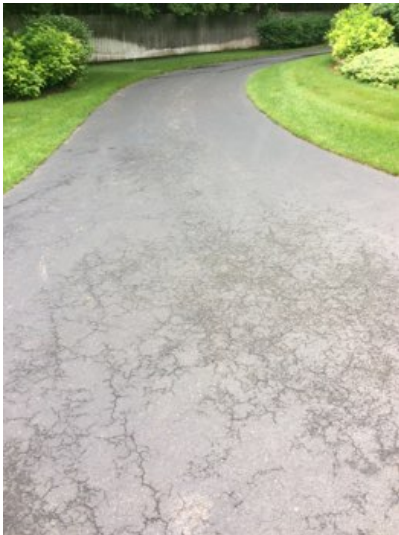
Asphalt driveway-We recommend sealing any small cracks in drive to prevent further expansion.

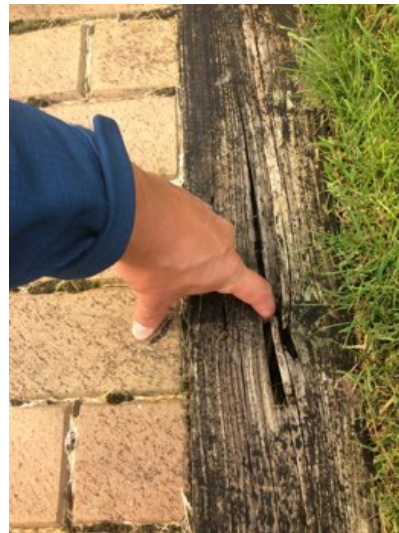
N brick water walkway-multiple landscaping timbers observed to have decayed areas, we recommend replacing to prevent bricks from settling/shifting.

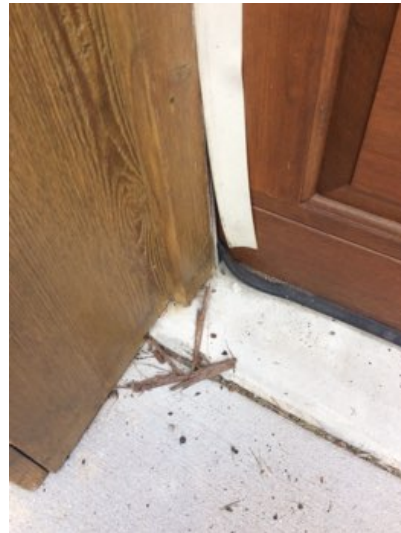
Loose weather stripping observed at garage door corners should be secured for proper weather proofing.

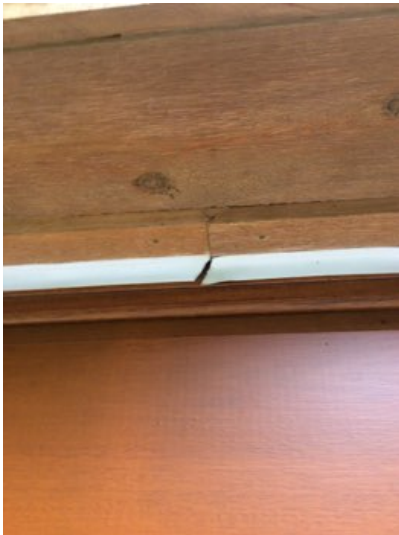
Seam in garage door weather stripping should be sealed to prevent water intrusion.

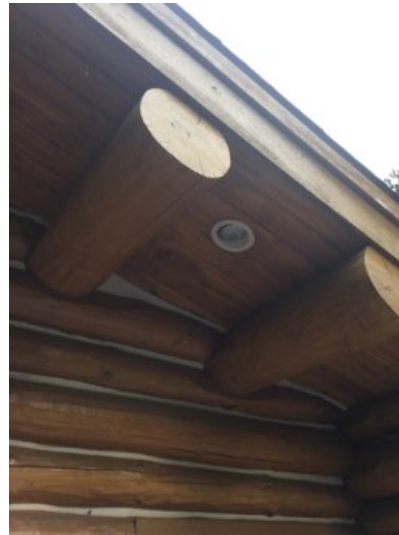
Garage light above S service door appears to be burnt out at time of inspection, we recommend consulting with the seller to verify.

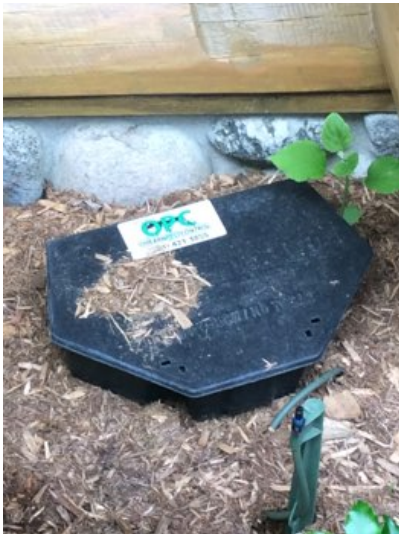
We recommend continuing baiting and monitoring unwanted pests.

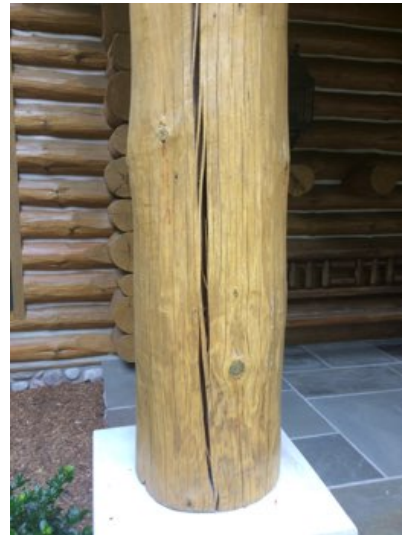
We recommend sealing any cracks in logs to prevent water damage and further expansion.

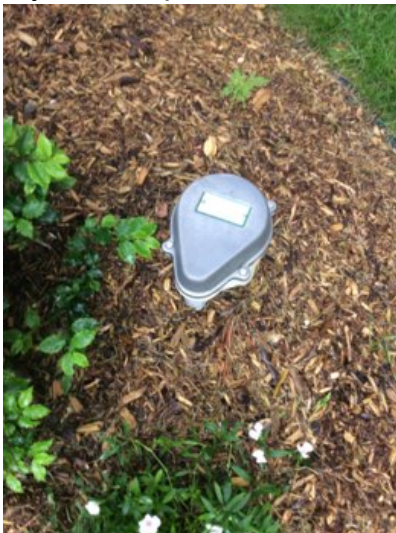
Well head appears secure

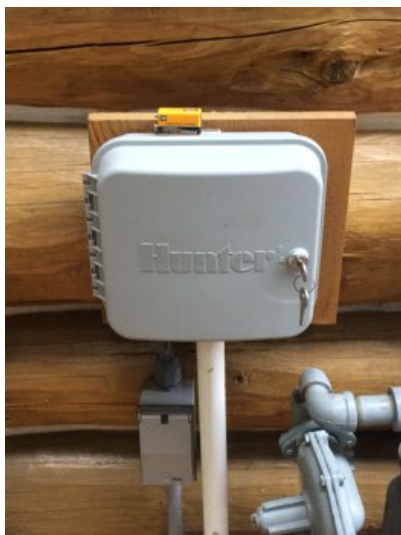
Irrigation system in place-we recommend consulting with the seller for user information and history as system was not tested at time of inspection due to the unseen intricacies of irrigation systems.

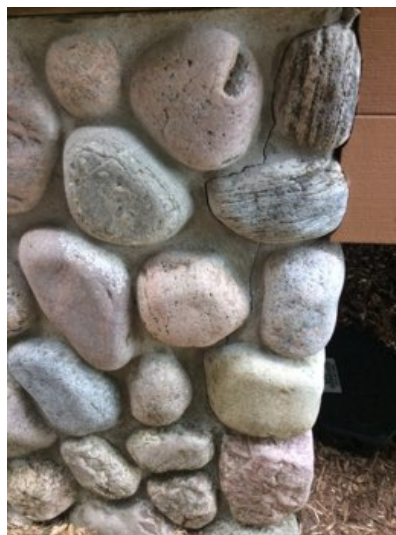
Cracked tuck pointing observed at lower NE corner should be patched and sealed to prevent further expansion.

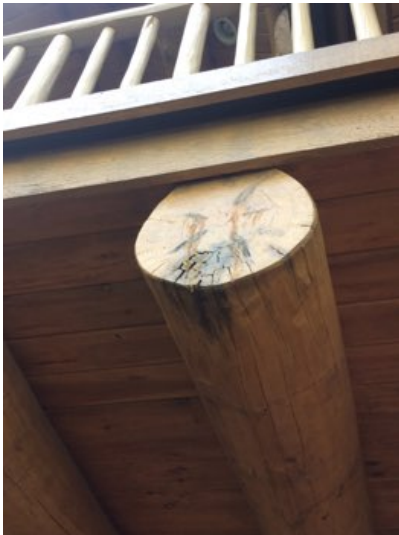
Decayed log tail observed on underside of upper NW deck.

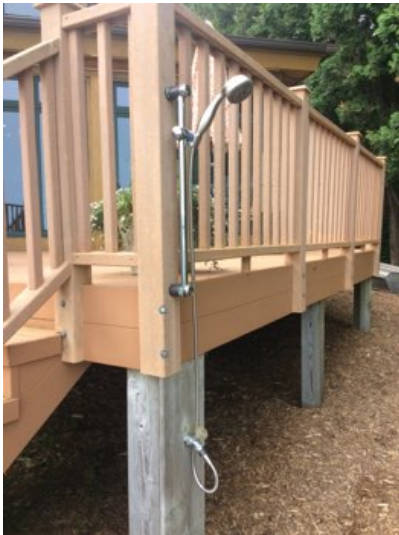
NW exterior shower not hooked up at time of inspection. We recommend consulting with the seller to verify function.

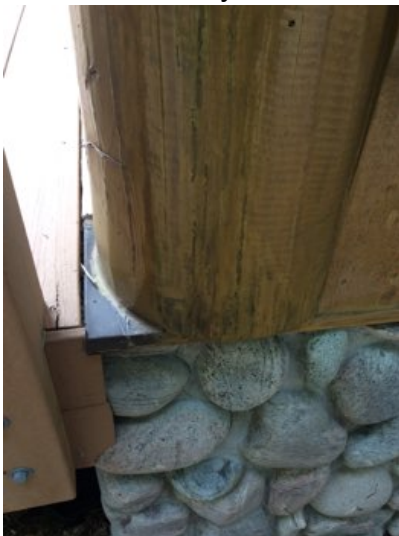
Decayed corner beam observed at NW corner of home.

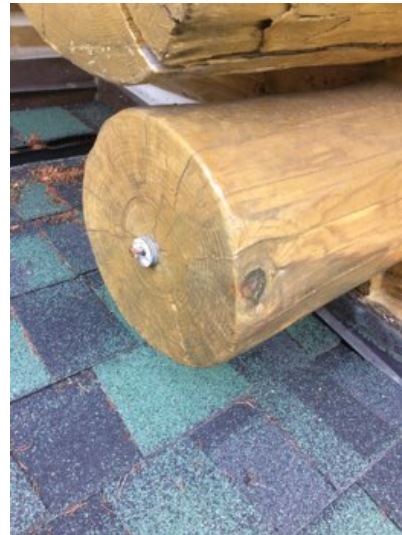
- Multiple cracks observed in logs around home. We recommend sealing any cracks to prevent water damage and further expansion. This is considered routine maintenance with logs homes.
- **Slight decay observed at SW corner of NE deck.**
- **Decayed log tail observed on underside of upper NW deck.**
- **Decayed base of corner beam observed at NW corner of home.**
- **Slight decay observed in log tail at upper SW corner of S entry patio.**

Slight decay observed in log tail at upper SW corner of S entry patio.

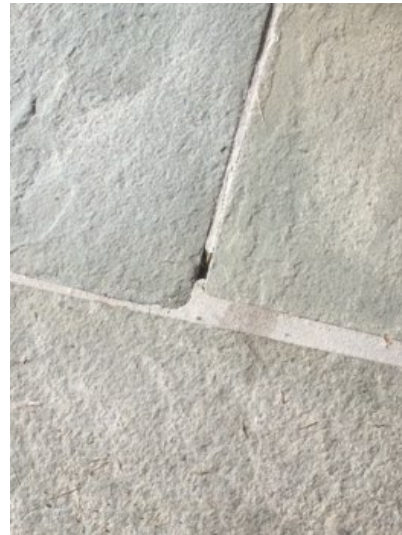
Cracked tuck pointing observed at S entry patio, we recommend sealing these areas to prevent further expansion/deterioration.

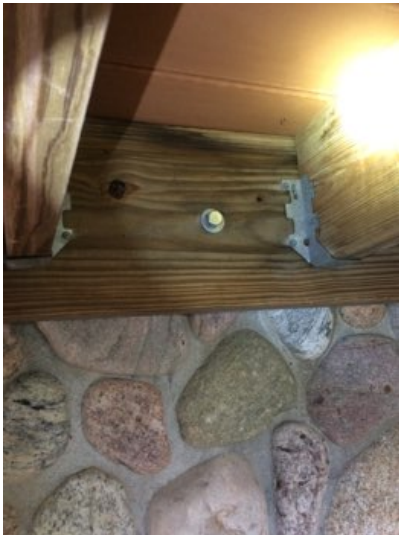
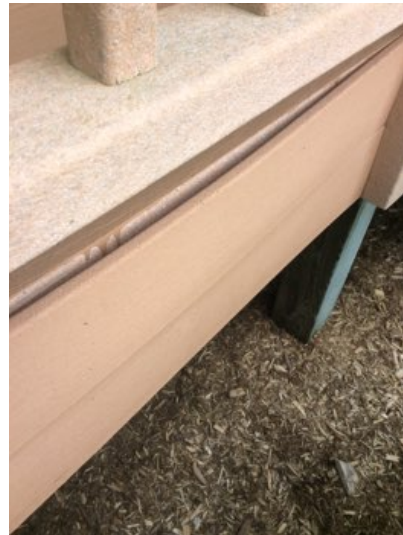
NE Deck 2x8 construction on 16" centers with 6x6 supports. Ledger board is bolted and not flashed. We recommend properly flashing the ledger board for improved deck safety.

Loose face boards observed at lower NE corner of NE deck should be secured.

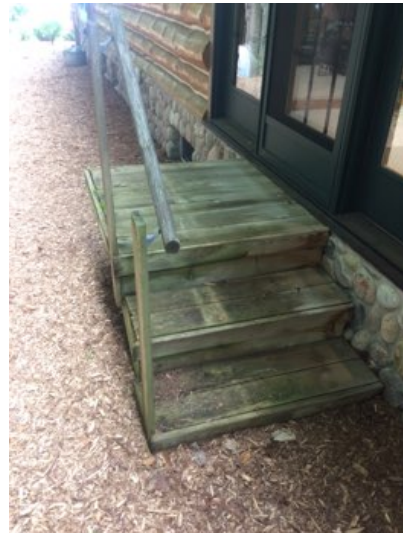
W side entry deck-deck boards/trim starting to decay and hand rail loose and should be replaced.

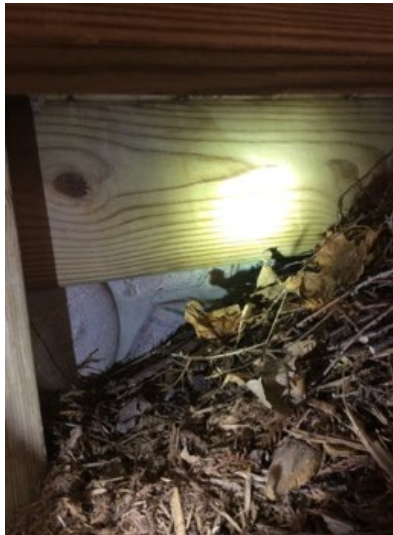
W side entry deck not attached to home-2x8 construction on 16" centers on 6x6 supports.

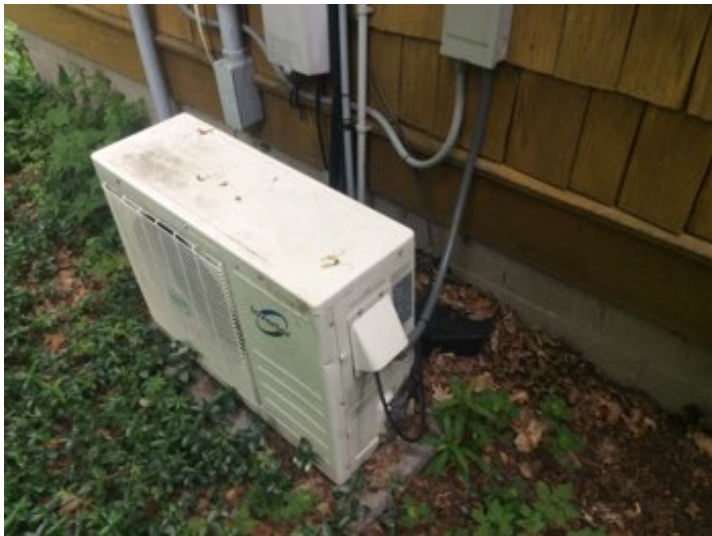
Consult with the seller for split system installation date for age of unit. Typical lifespan is 7-15 years.

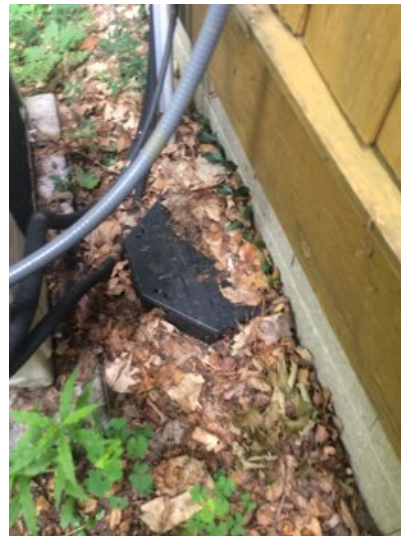
Signs of rodent baiting observed. We recommend continued baiting and monitoring as rodents can damage framing, wiring and insulation.

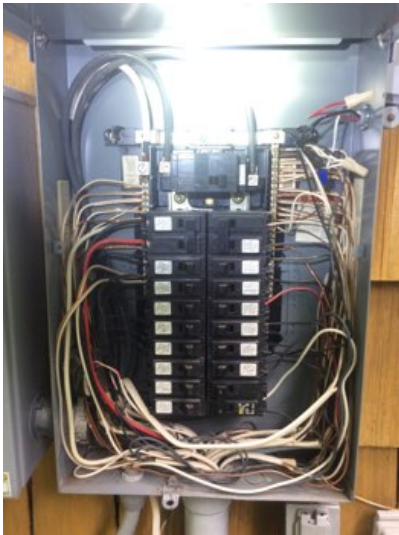
Outbuilding service panel ledger appears to be complete. Missing panel cover screw should be installed.

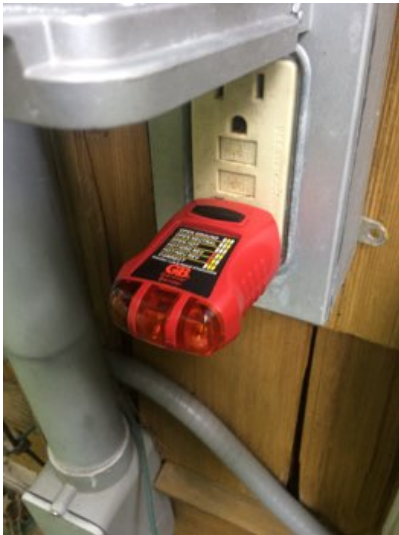
• **Outbuilding service panel: Double tapped breaker(s) inside panel box (more than one electrical conductor attached). This is not standard practice, and may cause overheating or even an electrical fire. Recommend evaluation by an electrician. Double tapping and lugging can create hot spots on breakers and neutral bars because they are not tightened to the correct torque--especially if two different size conductors are used. Because the hot [black] and neutral [white] wires are both current carrying conductors, the chance is then greater for potential hot spots. If the **double tap** or lug becomes loose, it begins to arc. As it arcs it builds up carbon. Carbon is then resistance and with more carbon buildup the more difficult it is for the conductor to make contact, thus increasing the current. The end result can be the breaker tripping because of the loose connection [current exceeding the rating of the breaker], or signs of overheating such as discolored wires, melted wires, etc, or even fire.**

Outbuilding service panel: Double tapped breaker(s) inside panel box (more than one electrical conductor attached). This is not standard practice, and may cause overheating or even an electrical fire. Recommend evaluation by an electrician. Double tapping and lugging can create hot spots on breakers and neutral bars because they are not tightened to the correct torque--especially if two different size conductors are used. Because the hot [black] and neutral [white] wires are both current carrying conductors, the chance is then greater for potential hot spots. If the double tap or lug becomes loose, it begins to arc. As it arcs it builds up carbon. Carbon is then resistance and with more carbon buildup the more difficult it is for the conductor to make contact, thus increasing the current. The end result can be the breaker tripping because of the loose connection [current exceeding the rating of the breaker], or signs of overheating such as discolored wires, melted wires, etc, or even fire.

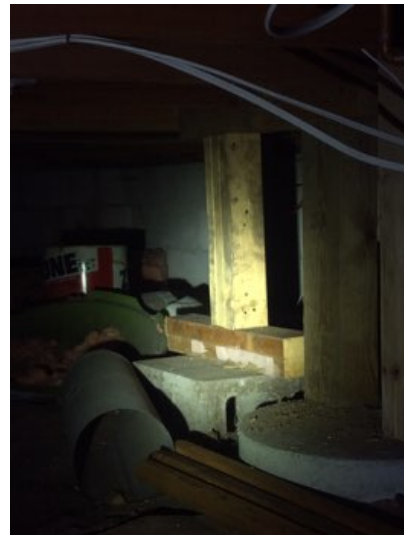
Improperly set block support should be adjusted. We recommend a qualified contractor evaluate and repair as needed to improve support.

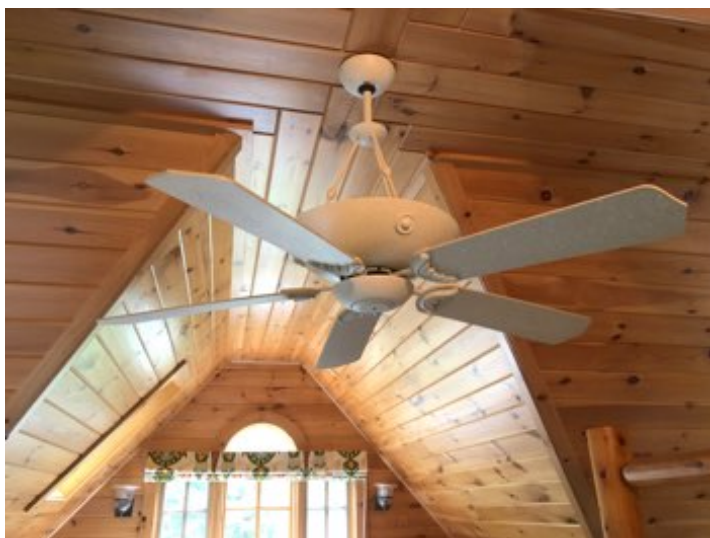
Fan responded to wall control

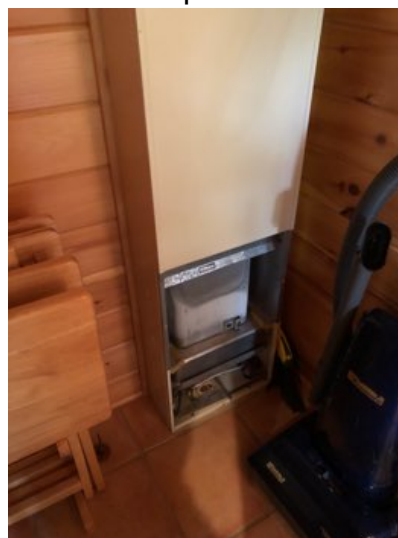
Gas wall heater, unit responded to thermostat, located on kitchen wall

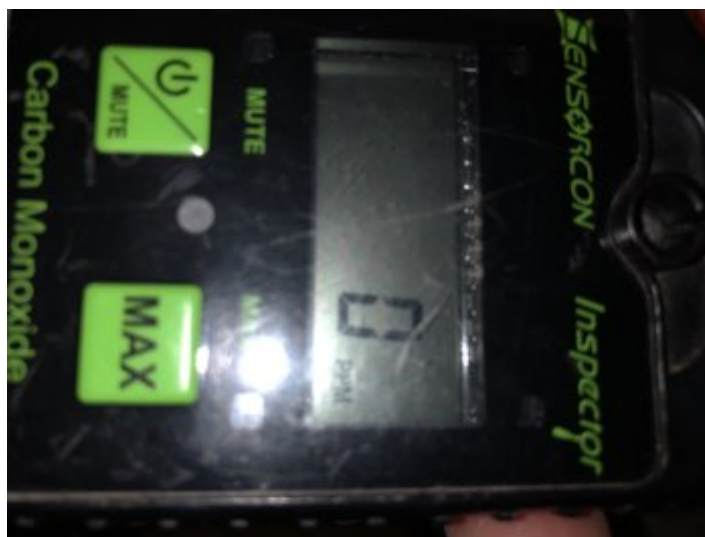
Wall unit tested negative for CO production

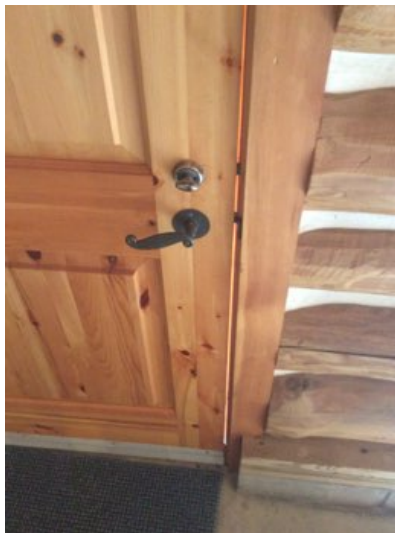
Weather stripping at service door should be improved

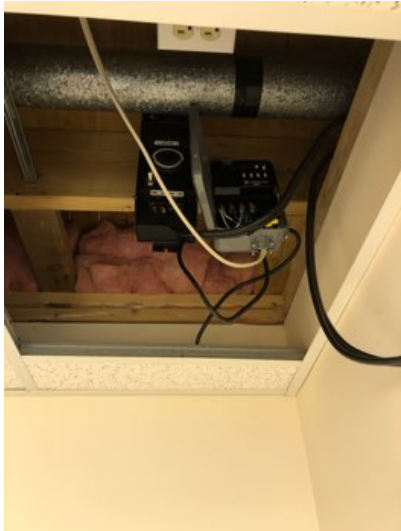
SW storage area ceiling, ceiling tile has been removed loose wire is not energized, timing devices have been installed wiring appears secure we recommend consulting with seller for further information about these units

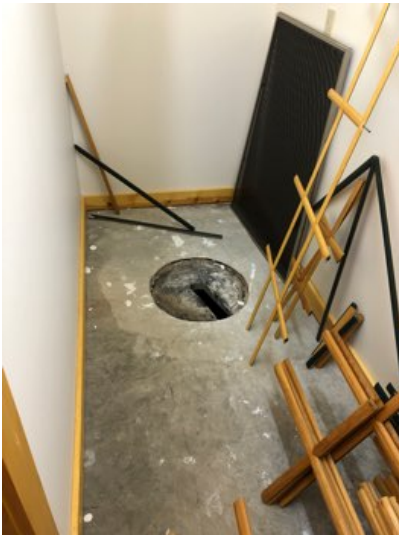
North east storage room: a crock has been installed, no pump present, inside crock is dry

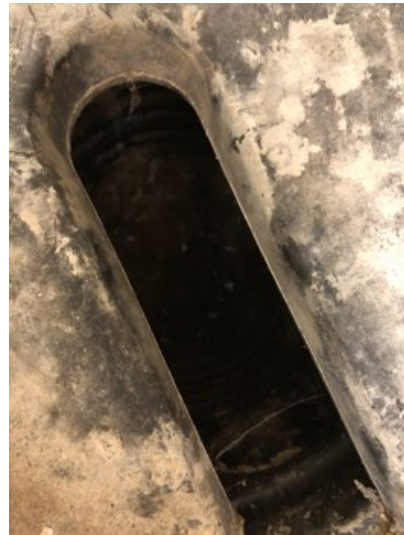
Crock floor is dry

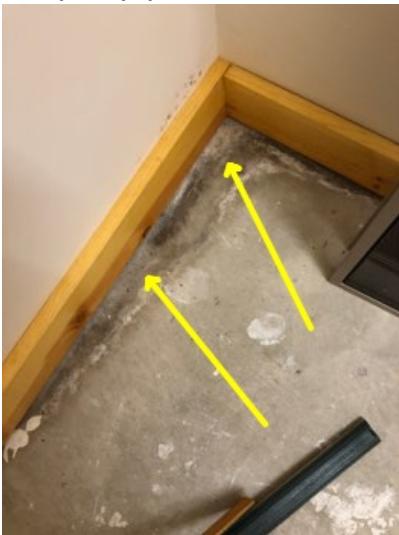
- **North east storage room near crock: concrete floor has water staining with hard water deposits. Although the area was dry during inspection this is an indication of repeated wetting. We recommend consulting with seller for history of water intrusion**

North east storage room near crock: concrete floor has water staining with hard water deposits. Although the area was dry during inspection this is an indication of repeated wetting. We recommend consulting with seller for history of water intrusion

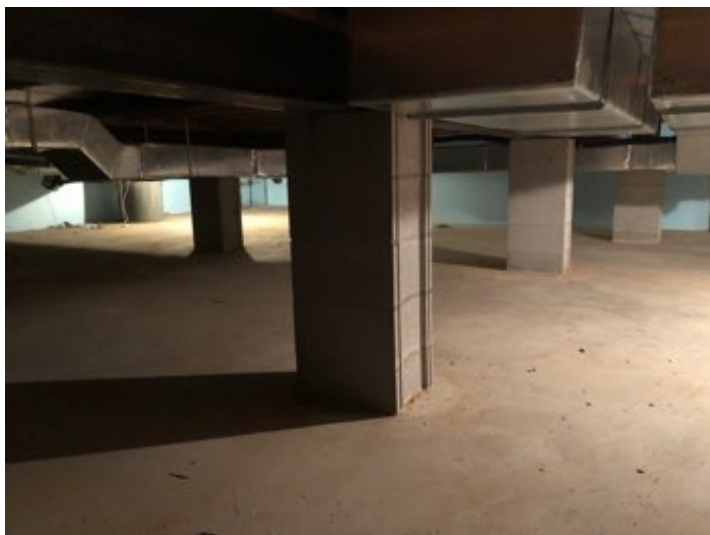
Crawl Southview: Concrete block column supports are secure floor joists are supported with steel I-beams. Exterior walls are insulated with 1 inch foam board

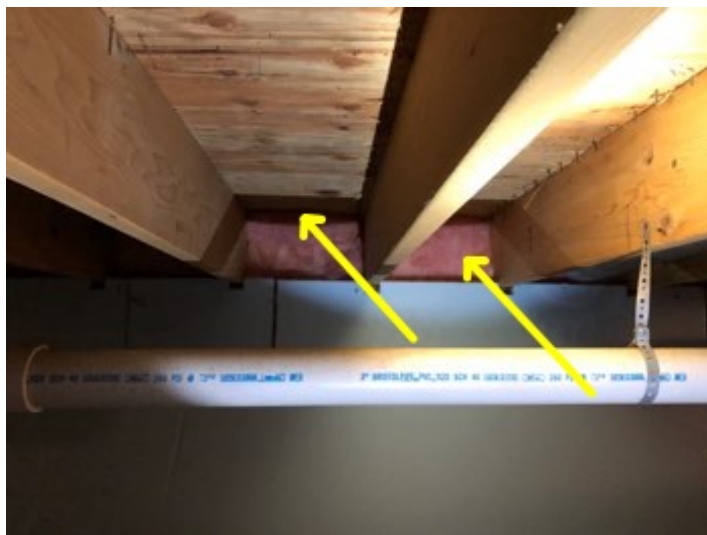
Crawl space: visible rim joists are insulated

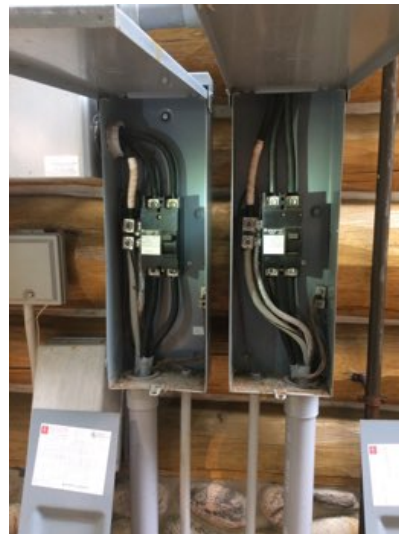
Service panels covers removed.

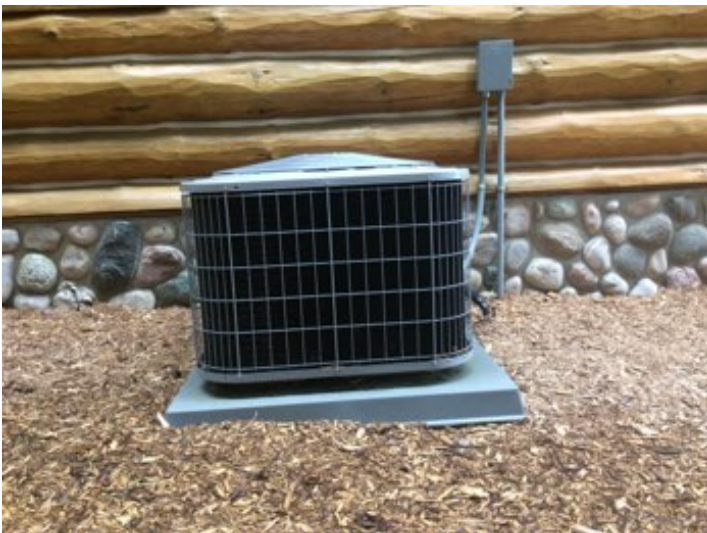
Carrier A/C condenser with electrical shutoff present

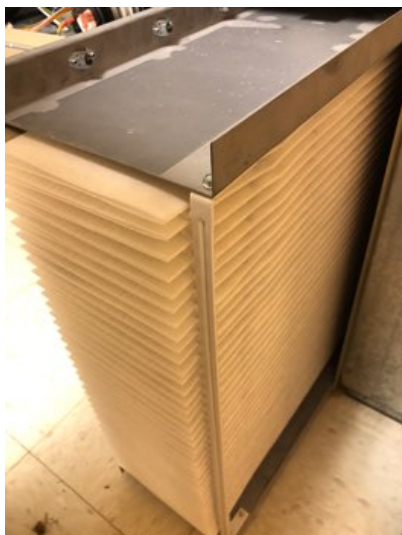
West unit filter is clean

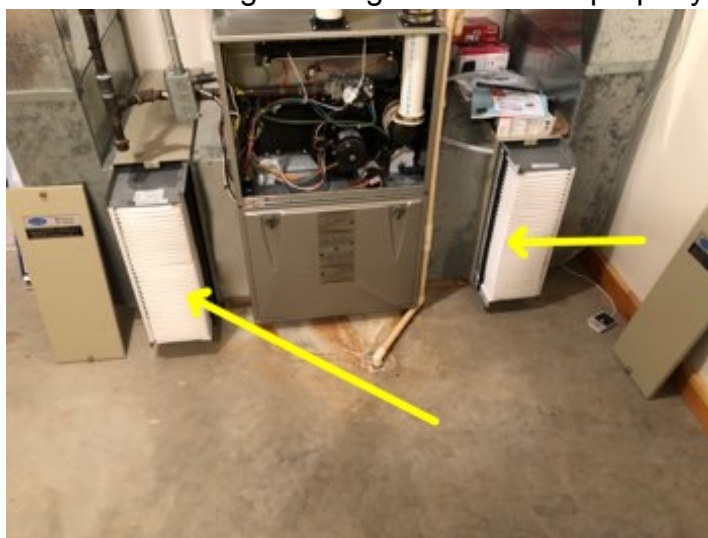
East unit filters are clean

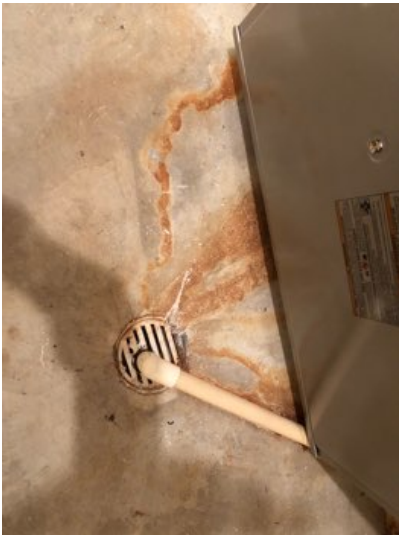
East unit: Water staining under unit on concrete floor. This area was dry during the inspection. Moisture appears to have originated from condensate line. Although this can be common when humidifier systems are used, we recommend consulting with an HVAC technician to clean condensate lines regularly.

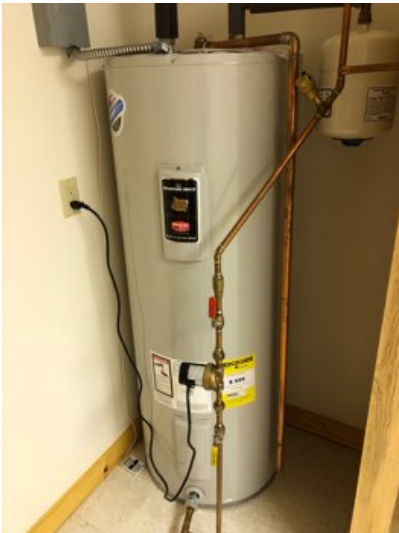
West unit

- Electric water heaters: west unit is Bradford white brand, 50 gallon. East unit is rheem brand, 47 gallon. Units responded to hot water testing. Average service life of a hot water heater is 5-15 years. Manufacture dating for both units is 2016
- **TPR valve**s are secure

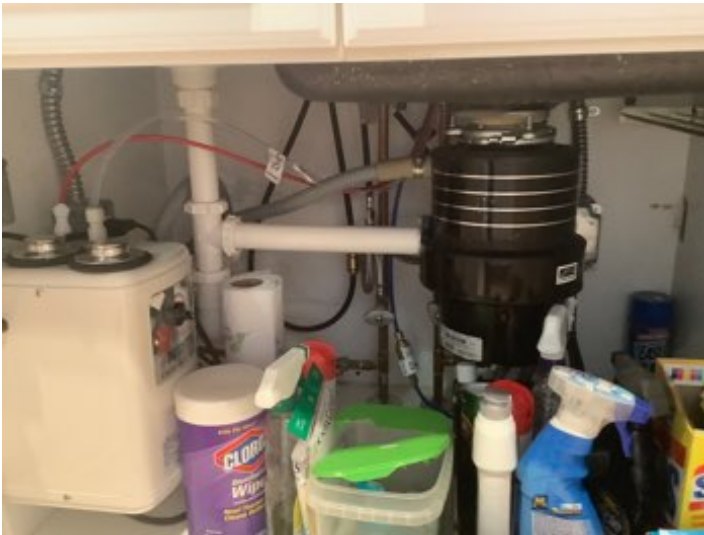
On demand water heater appears to be functioning properly.

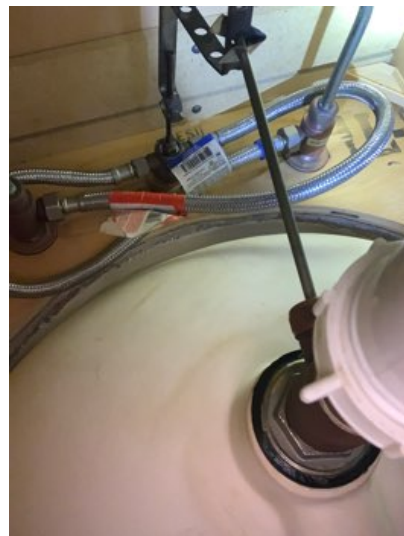
- GFCI receptacles trip tested and reset, appeared to function properly
- Light fixture secure and functioning properly
- Mirror secure to wall
- Adequate water pressure observed at sink. Handle and faucet secure and functioning properly.
- P-trap dry and secure at the time of inspection
- Vanity cabinets/drawers function properly
- Exhaust fan functions properly
- Toilet secure to floor and appears to be functioning properly
- Adequate water pressure observed at bath faucet and shower heads
- Shower head water line, handle, and faucet all secure and functioning properly
- No holes or cracks observed in shower
- Shower door functions properly
- We recommend sealing grout cracks at base of tub
- Electric wall heater functioning properly
- **Leak observed below faucet, we recommend sealing.**

Leak observed below faucet, we recommend sealing.

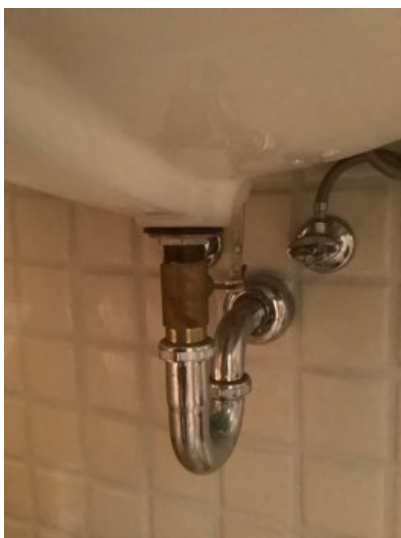
- GFCI receptacles trip tested and reset, appeared to function properly
- Light fixture secure and functioning properly
- Mirror secure to wall
- Adequate water pressure observed at sink. Handle and faucet secure and functioning properly.
- P-trap secure at the time of inspection
- Exhaust fan functions properly
- Toilet secure to floor and appears to be functioning properly
- Adequate water pressure observed at shower head
- Shower head water line and handle secure and functioning properly
- No holes or cracks observed in shower
- Shower door functions properly
- **Leak observed under faucet, we recommend sealing.**

Leak observed under faucet, we recommend sealing.

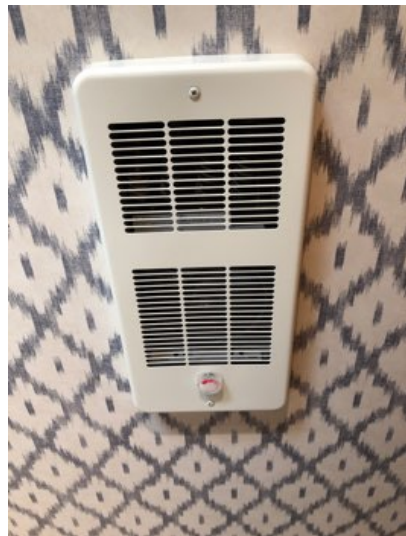
Electric wall heater functioned

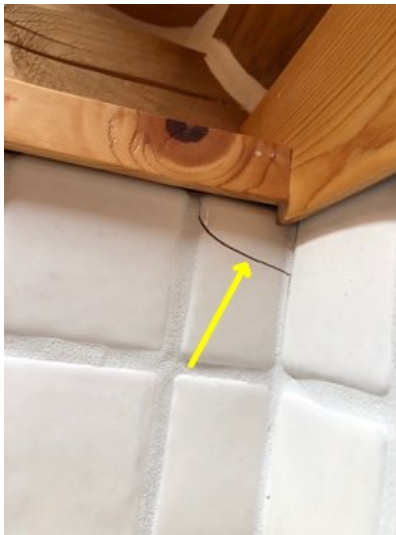
Cracked tile in tub/shower upper corner

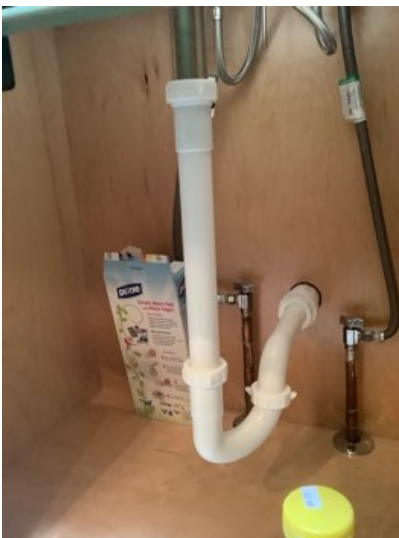
W sink drain stop not functioning properly

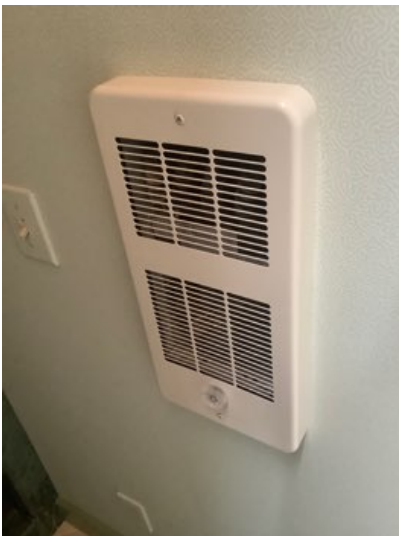
Electric wall heater functioned, but is loud. We recommend adjusting.

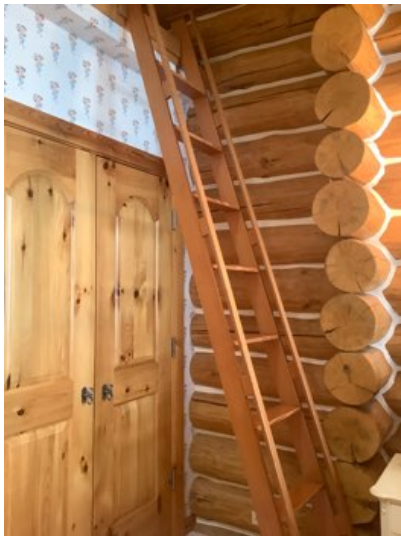
N bedroom: we recommend properly securing loft ladder to improve safety

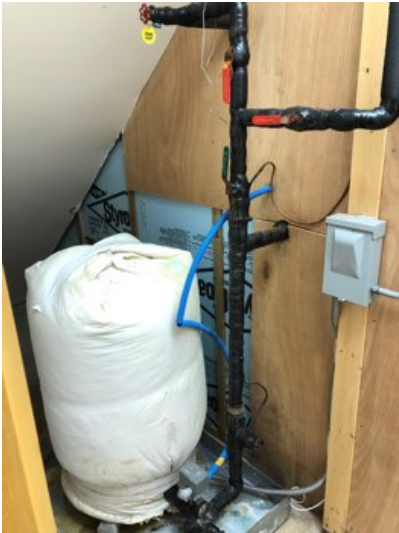
Water main line is secure. Some corrosion on ball valves. Shut offs appear secure

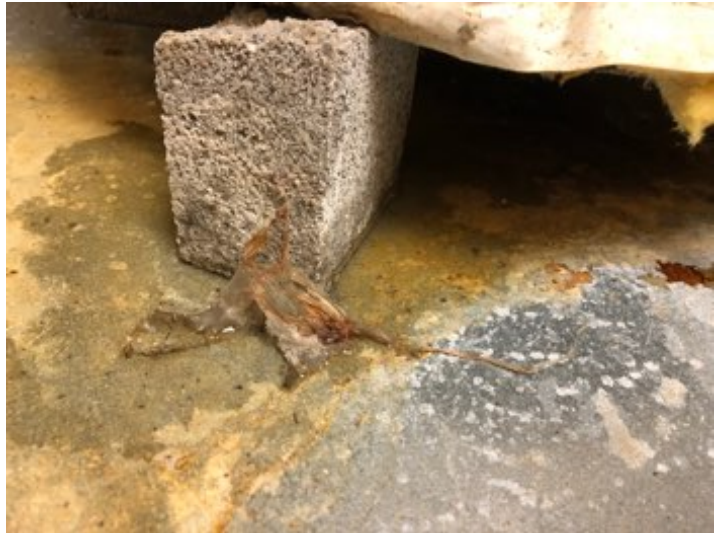
Water at base of pressure tank appears to be from condensation, moisture is localized in drop pan

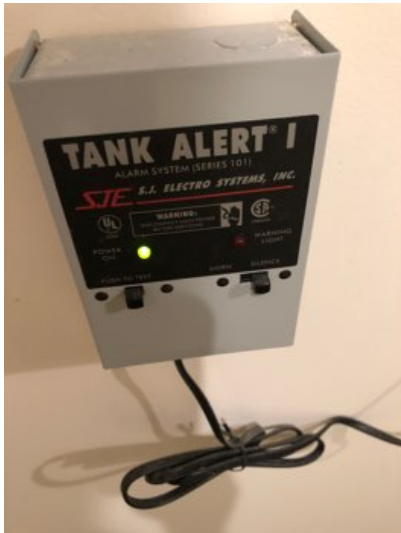
Septic tank alert sounded when tested

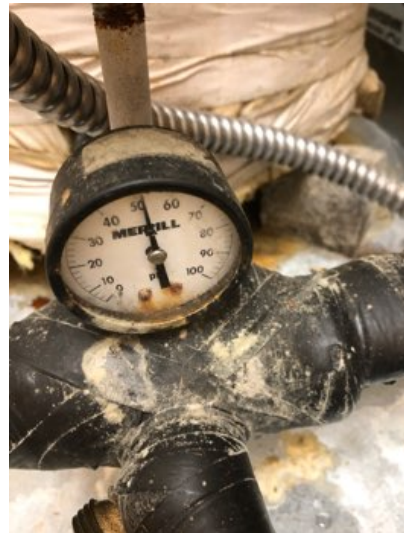
Although the well appeared to cycle properly and good water pressure was observed throughout the home, pressure gauge did not function. We do recommend replacing the pressure gauge to get an accurate pressure reading.

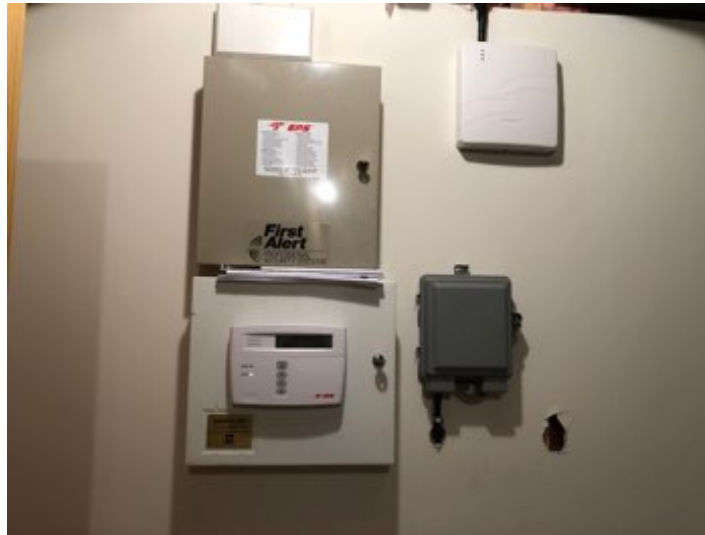
This home is equipped with a security system, we recommend consulting with seller for maintenance history and function of the system. security systems vary and are often equipped with a transferable warranty

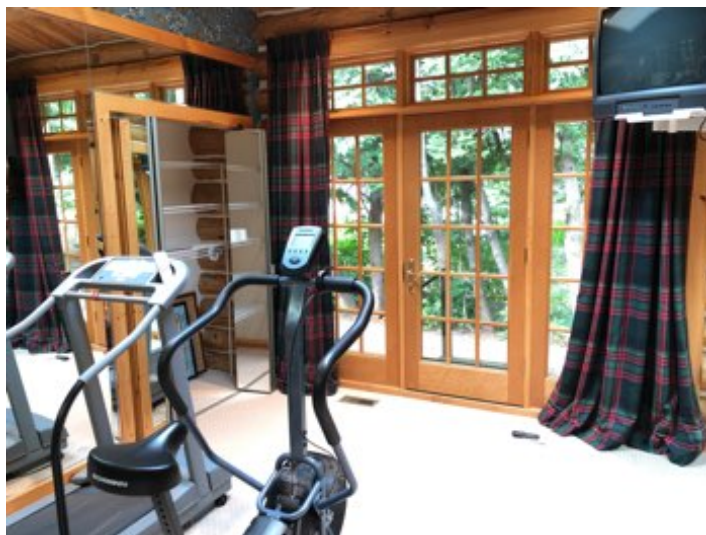
Exercise room

Water staining observed in front of N living room entry doors, area tested dry at time of inspection.

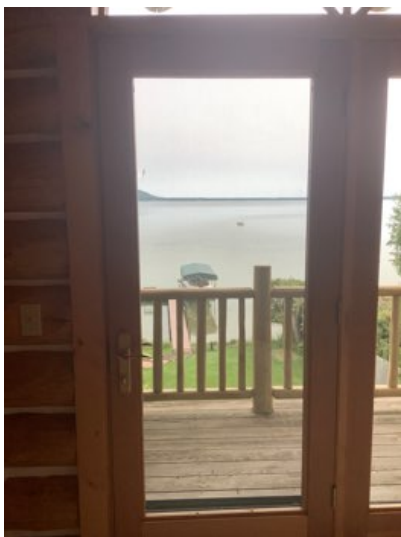
Master bedroom: door is difficult to open/close and latch. We recommend adjusting.

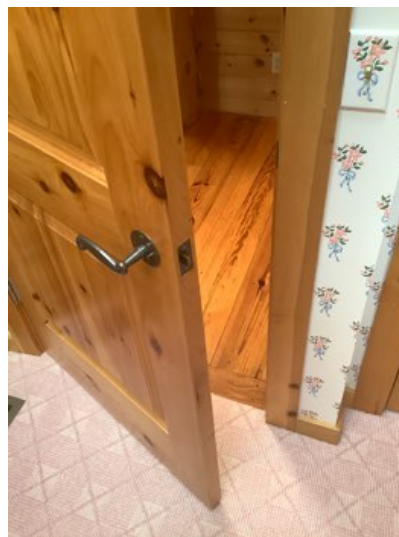
N bedroom: door doesn't latch smoothly and lock not functioning properly.

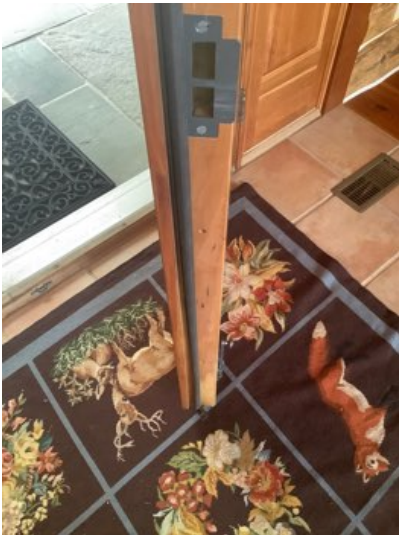
Front entryway: we recommend securing weatherstripping on right door and sealing grout cracks at door threshold.

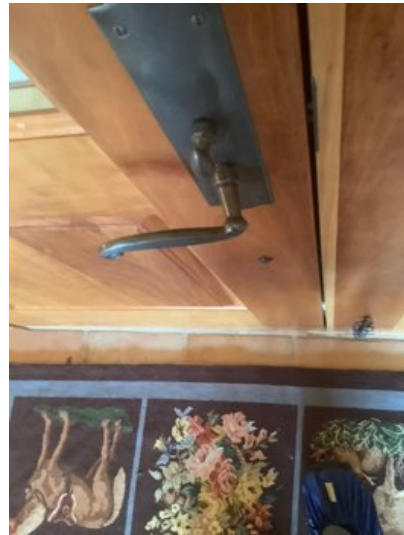
Front entryway: left door handle is crooked

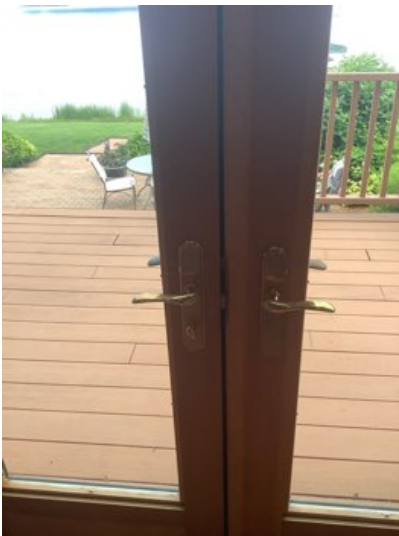
E living area: left and right N exterior doors don't latch properly, but do lock. We recommend adjusting.

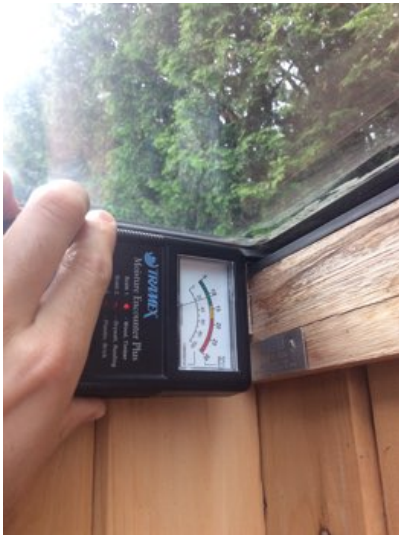
Staining at the kitchen skylight window tested dry at time of inspection with moisture meter

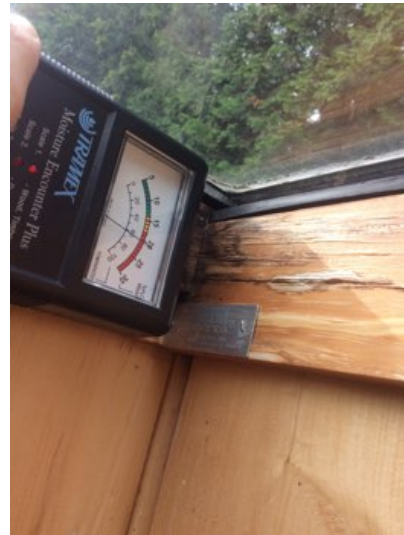
- No major system safety or function concerns noted at time of inspection
- All accessible windows were tested during the inspection. Any discrepancies are noted below
- **Staining at the gym skylight window tested slightly damp at time of inspection with moisture meter. We recommend a qualified contractor evaluate and repair as needed.**

Staining at the gym skylight window tested slightly damp at time of inspection with moisture meter. We recommend a qualified contractor evaluate and repair as needed.

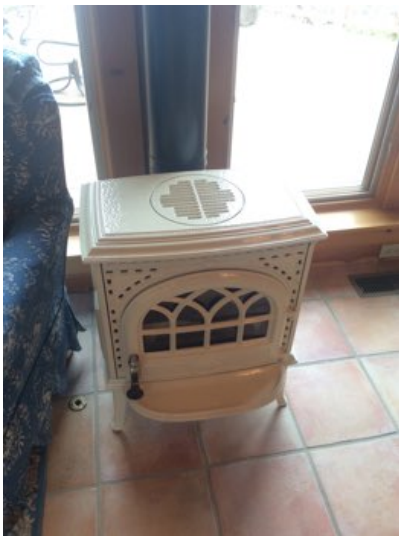
Kitchen dining area gas fireplace igniter would not spark at the time of inspection for inspector. Consult with seller for user information. Igniters can go bad over time and may need to be replaced.

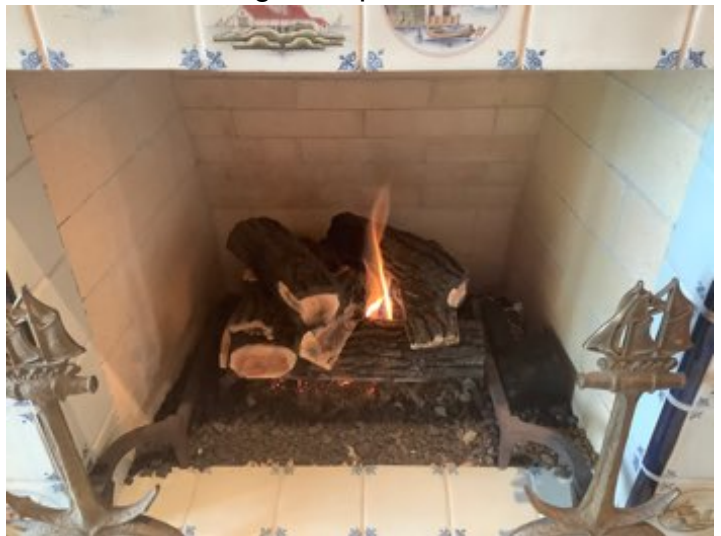
W living area: gas burning fireplace tested and functioned properly. We recommend installing some sort of door or cover for fireplace.

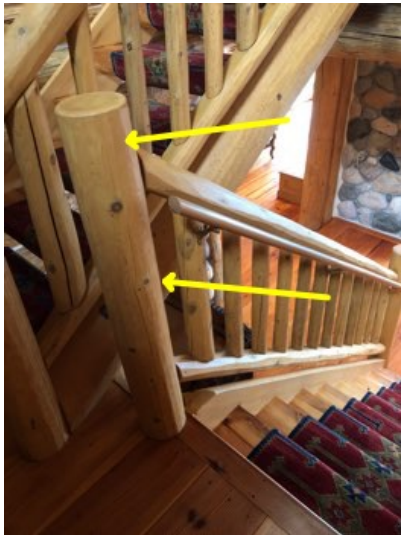
West lower railing is slightly loose and should be secured
